Cracked Cast Iron Bearing Housings

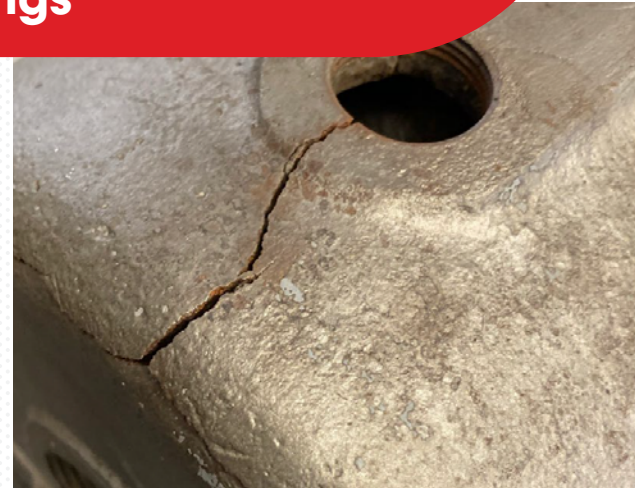
During a freeze event in Texas, a major refinery experienced failures of several bearing housings. The bearings were water cooled and when the plant lost power they also lost cooling water flow. The cast iron bearing housings cracked from water freezing in the housing. The entire refinery was shutdown due to the freeze event and several of the pumps with cracked bearing housings were required to restart the plant. The refinery required new or repaired bearing housings ASAP.

- Conhagen engineering was able to scan the existing bearing housings in 3-4 hours without delaying the pump overhaul.
- The pump bearing housings were repaired by brazing the cast iron as a temporary repair.

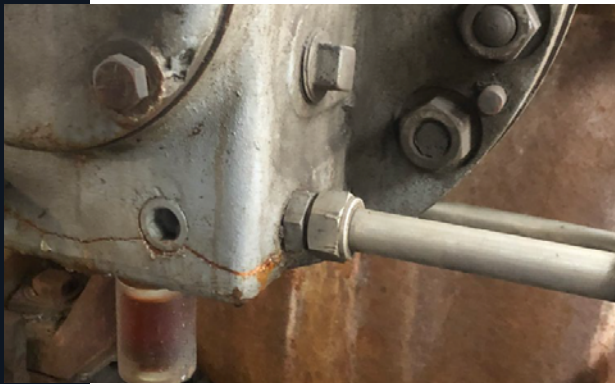
New Bearing Housing Style #1

Fabricated Water - Cooled Housing

The bearing housing was scanned prior to the temporary repair. Conhagen then fabricated a new carbon steel bearing housing. The new carbon steel construction is now weld repairable.

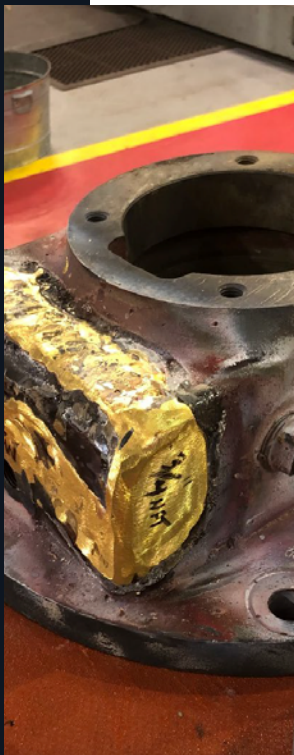
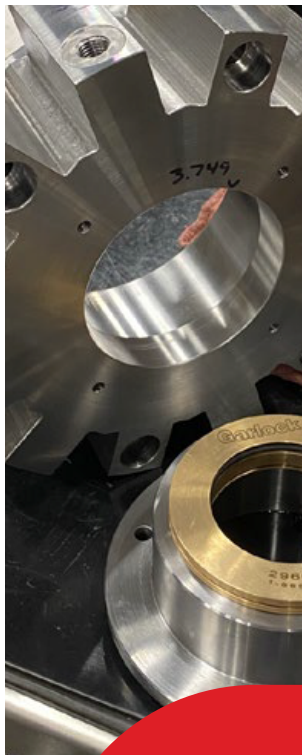
New Bearing Housing Style #2

Air - Cooled Housing

Conhagen engineering identified several of the frozen bearing housings could be re-designed to eliminate the cooling water entirely. The new housings are machined 410 steel and eliminate the failure mechanism entirely and still provide sufficient cooling to the bearing for reliable operation.
