## Boiler Feed Pump Reliability Upgrade

Upgrade boiler feed pumps to reduce failures and increase performance.

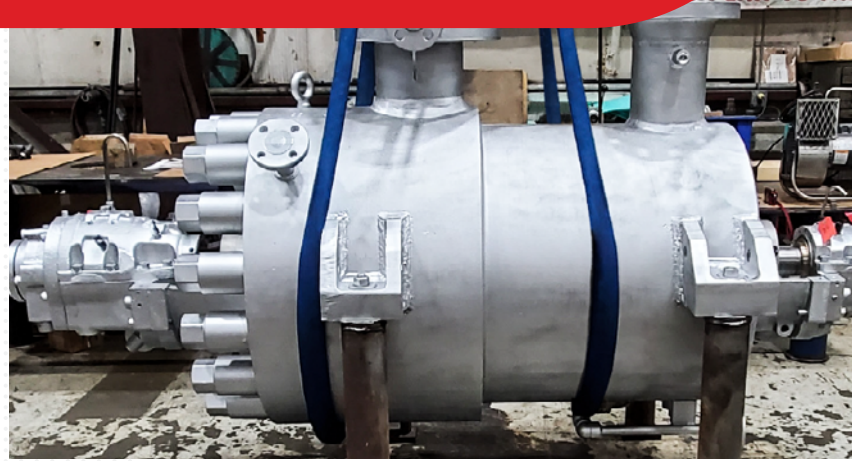
Historically these boiler feed water pumps have suffered from premature failures and reduced performance. Damaged balance drums or wear rings have led to failed bearings and impellers contacting the diffusers.

- Upgrade stationary eye seal material.
- Upgrade stationary impeller hub seal material.
- Mechanically lock the wear rings in place without the use of fasteners using Conhagen's clic-loc tongue & groove design.
- Add pressure reducing grooves to the high-pressure bushing for enhances rotodynamic stability.
- Install composite material in the balance drum assembly to allow for intermittent dry-running.
- Perform rotodynamic analysis to confirm compliance to API 610 stability requirements for the upgrade.

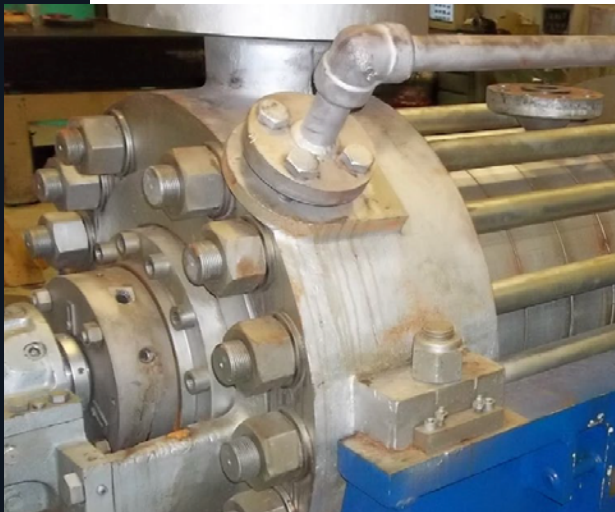
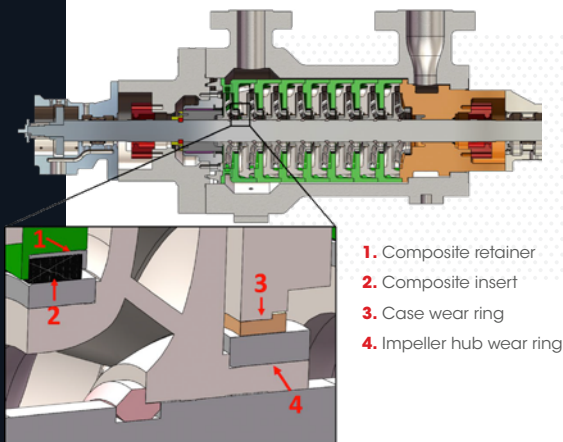
Conhagen has several of these upgrades installed across multiple customer sites, one of the early conversion pumps was pulled recently for scheduled overhaul after 12 years and wear rings were found to be in "like new" condition.

By upgrading to non-metallic rings the pump efficiency can be improved. The non-metallic wear rings allow tightening of ring clearances (50-75% of API) which improves pump efficiency. This upgrade can be easily applied during a scheduled overhaul, all the changes are internal to the pump components and will not affect any piping or auxiliary systems. Typically, this upgrade can be approved with a standard MOC process.
